IP-3 Revision: September 2009 2010 Altima

SQUEAK AND RATTLE TROUBLE DIAGNOSES

INSTRUMENT PANEL ASSEMBLY

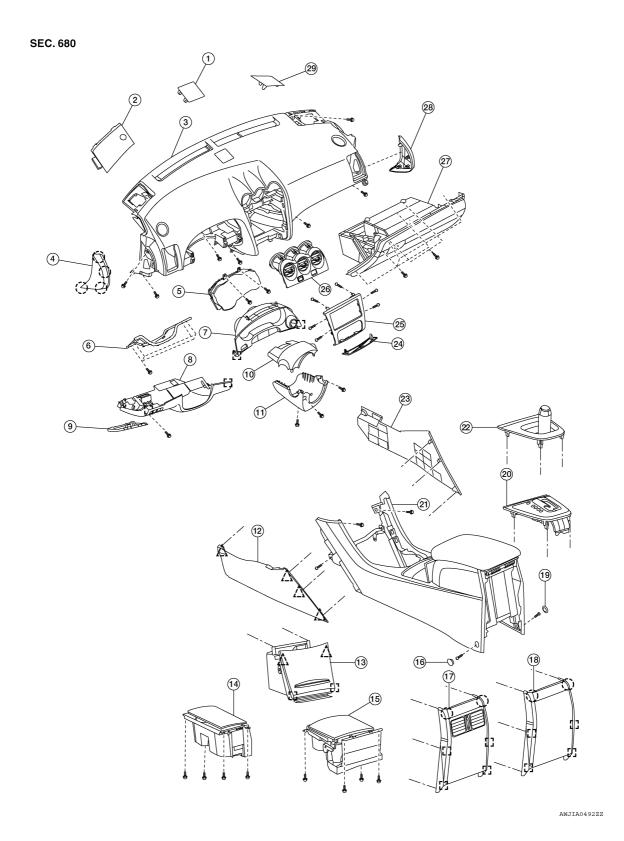
Exploded View

- 1. Center speaker grille
- 4. Instrument side mask (LH)
- 7. Cluster lid A
- 10. Steering column cover upper
- 13. Storage bin
- 16. Console screw cover (LH)
- 19. Console screw cover (RH)
- 22. M/T finisher
- 25. Cluster lid C
- 28. Instrument side mask (RH)
- [] Metal clip

- 2. Tweeter speaker grille (LH)
- 5. Combination meter
- 8. Instrument lower cover (LH)
- 11. Steering column cover lower
- 14. Cup holder M/T
- 17. Console rear finisher (if equipped with rear duct)
- 20. CVT finisher
- 23. Console side finisher (RH)
- 26. Center ventilator grilles
- 29. Tweeter speaker grille (RH)
- ⁻\ Pawl

- 3. Instrument panel
- 6. Lower knee protector (LH)
- 9. Fuse block cover
- 12. Console side finisher (LH)
- 15. Cup holder CVT
- Console rear finisher (without rear duct)
- 21. Console
- 24. Cluster lid D
- 27. Glove box assembly
- ,^ Clip
